**DRAFT REPORT  
STREAM MANAGEMENT PLAN  
PHASE 3**

**GRAND COUNTY, COLORADO**

**August 2010**

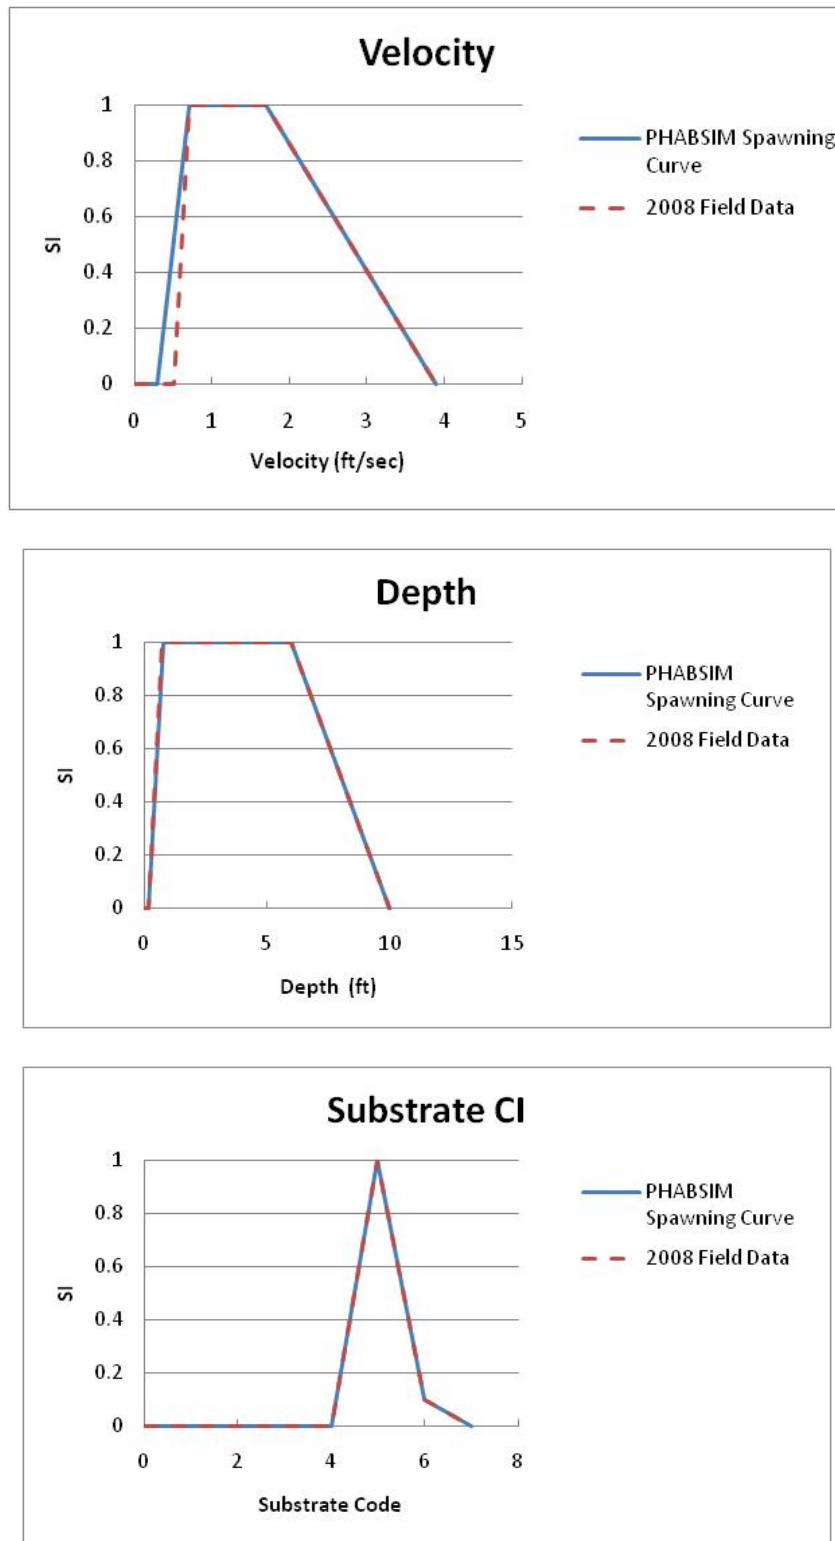
**Figure ES-3. Spawning Suitability Curves**  
 The velocity, depth and substrate channel index (CI) spawning suitability curves used for the PHABSIM studies as compared to trout redd data collected in Fall 2008.

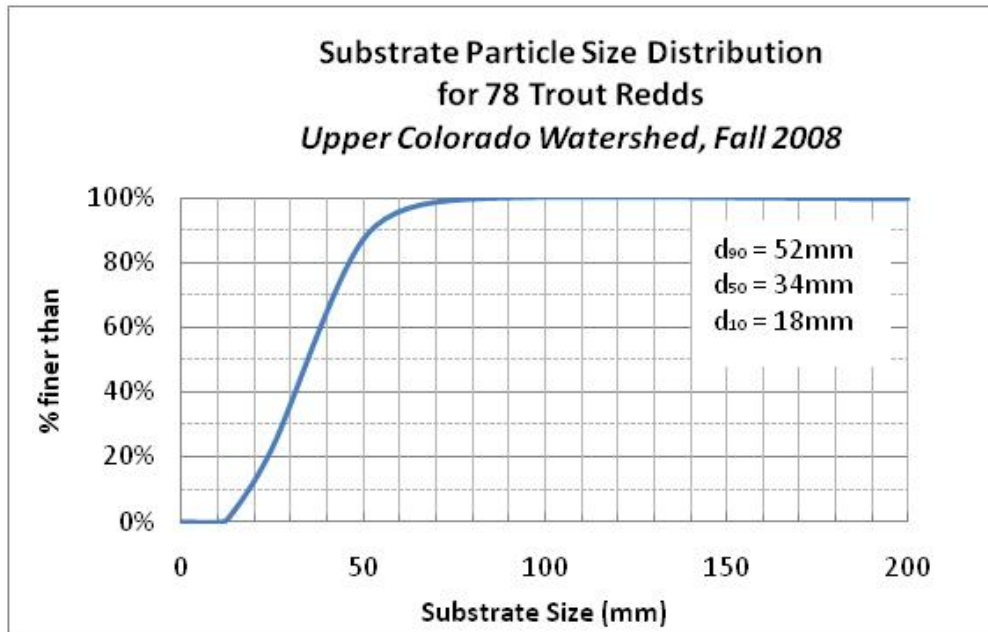
**Figure ES-4. Substrate Particle Size Distribution Plot**

Substrate particle size distribution plot of 78 trout redds collected in the Upper Colorado River basin, Fall 2008.

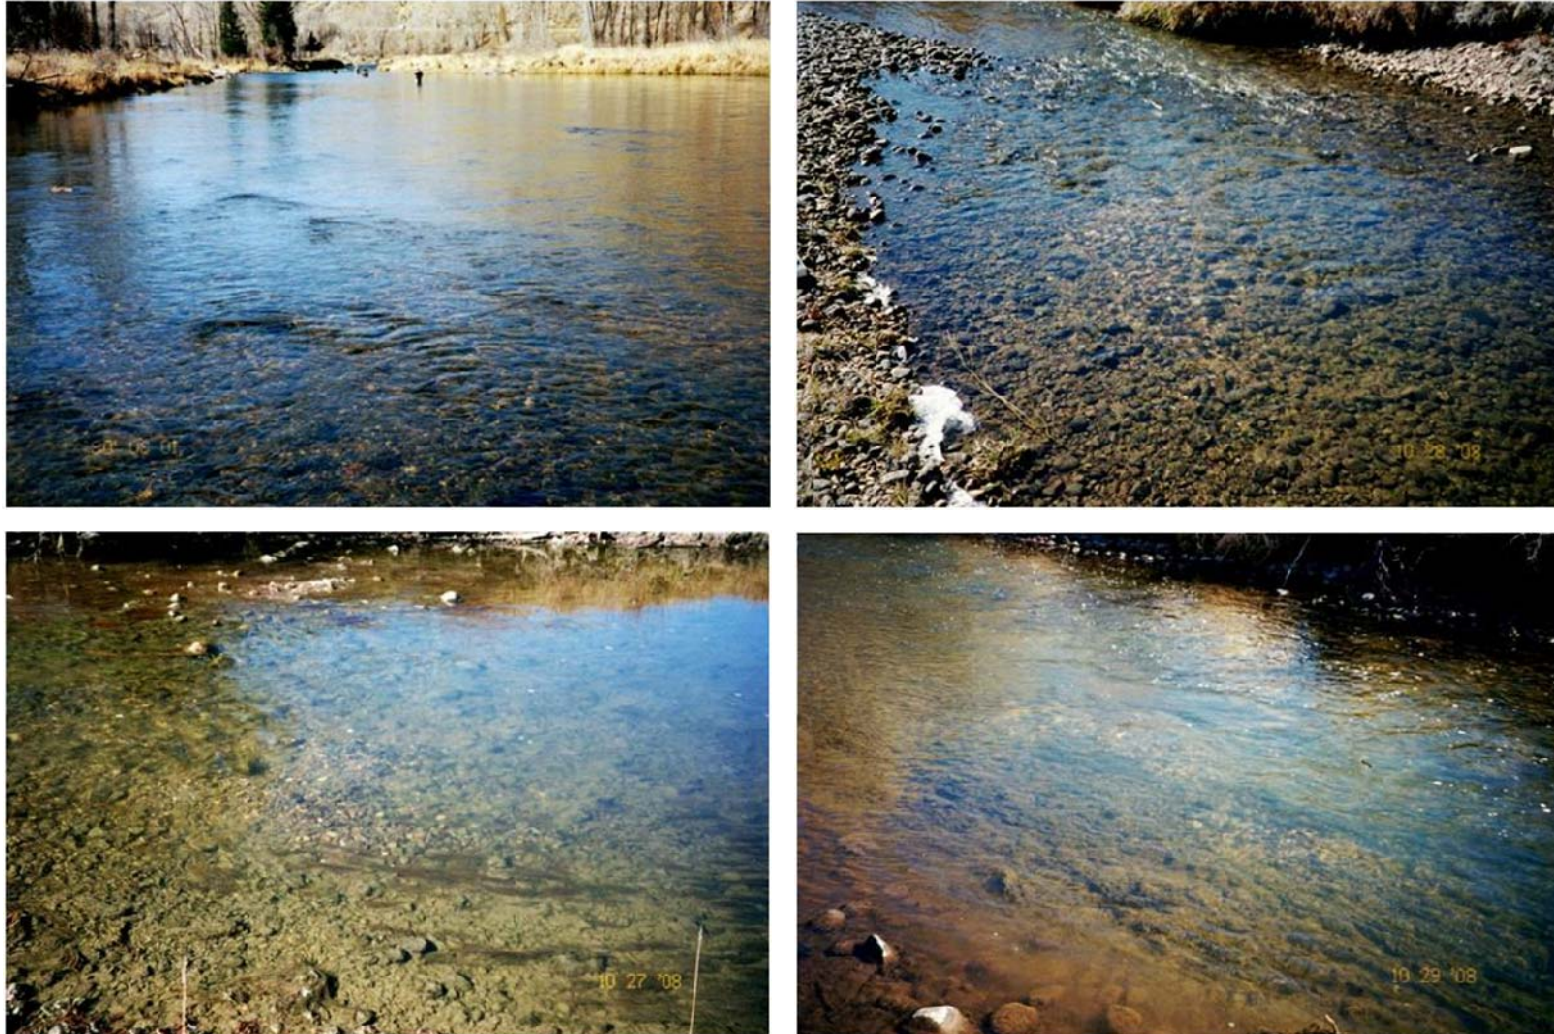
**Figure ES-5 Embedded Spawning Bars**

*Upper left: Brown trout redds in a relatively “clean” spawning bar in Colorado River, CR5, below Parshall.*

The brown trout spawning survey was conducted in October 2008 to 1) document spawning activity at and in the vicinity of our PHABSIM sites, 2) identify important spawning bars within Grand County that could be monitored under future water and land development conditions, 3) collect physical habitat data to verify the habitat suitability curves used for PHABSIM modeling, and 4) measure stream bed particle diameters from trout redds to develop a field-based particle size distribution plot for use with bedload transport modeling for flushing flow determinations. Methods are described in Appendix A. In total, 78 brown trout redds were identified and measured, with numerous other likely redds observed but not measured due to limited field time. Popular spawning habitats were identified in the middle and lower Fraser River (F5, F6, and F9; 16 redds measured), lower Ranch Creek (F-RC2; 10 redds measured), Colorado River just above Windy Gap (lower CR3; 8 redds measured), the Colorado below Windy Gap (CR 4, 5, and 6; 27 redds measured), lower Williams Fork (6 redds measured), lower Muddy Creek (MC2; 11 redds measured), and the lower Blue River below Trough Road (numerous redds observed but not measured due to rapidly changing streamflow). Habitat suitability curves developed from the water depth, velocity and substrate data collected at these redds were similar to, and verified the use of, the spawning curves used for the PHABSIM analysis (Figure ES-3). The substrate particle sizes selected by trout for spawning fell primarily within the gravel range, with a median particle size of 34 mm (Figure ES-4). Field observations indicated that substrate quality at spawning sites was commonly diminished by high fine sediment levels, especially in lower Ranch Creek, the lower Blue River, Muddy Creek (MC2), and upper CR4 (Figure ES-5).
